GEOTECHNICAL MAPPING AS A TOOL IN THE ASSESSMENT OF STRATA CONTROL PROBLEMS IN PK-2 UNDERGROUND COAL MINE A CASE STUDY

D. N. Sharma*

Abstract

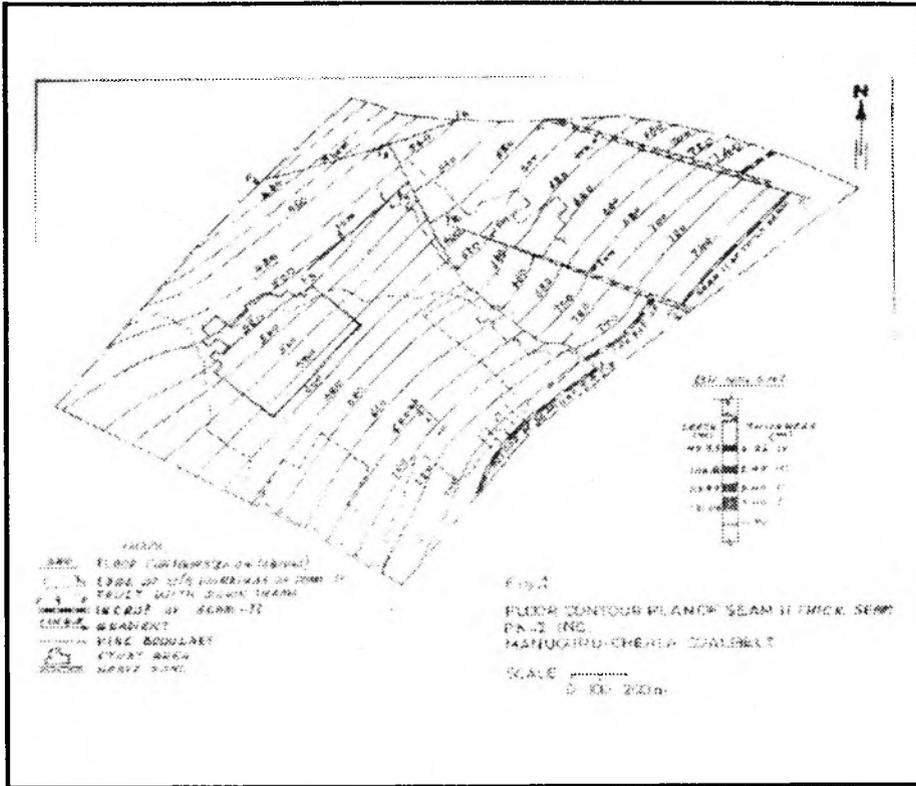
Fig.1

The PK-2 mine block is situated in the north eastern extremity of the Manuguru coalbelt. The trend of coal bearing strata is northeast - south west and with dip of NWLy dips of around 8 to 12° (Fig.1). The block is structurally less disturbed, since only four faults (mainly dip faults of normal gravity type) are observed to effect the seams.

In the dip side of PK-2 mine block, fault F5 is interpreted based on the available boreholes data. Considering the spot levels of underground workings of seam-II, the floor contours are drawn and found that position of fault F5 is shifted further dip side (Fig. -1). Keeping in view, the location of fault F5 with reference to 14 dip district workings, the unstable roof conditions might have prevailed.

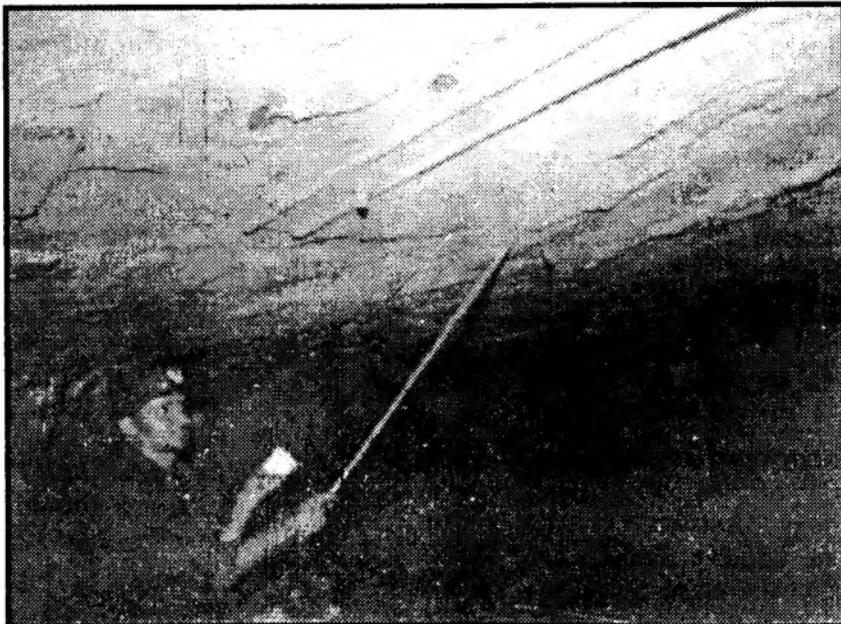
Fig.2

A detailed underground geo technical mapping has been carried out in the seam-I to pick up the trends of joints, sedimentary features, locating roof falls and their causative factors etc. It is noticed that within the study area, some times the workings are in top section with sandstone as immediate roof and elsewhere the workings are in middle section where part of the seam forms the immediate roof. It is found that in both cases the unstable roof conditions are prevailing. Thickness of the seam is drastically reducing in the dip side of 14-dip district. Conversely on the rise side, roof is stable (Fig.-2). Unstable roof conditions are observed only beyond 33L.workings.

While reducing the width of galleries, slight improvement in the roof stability is achieved. An attempt has been made to stagger the 34LS and 33LS in 14D to improve the roof conditions.

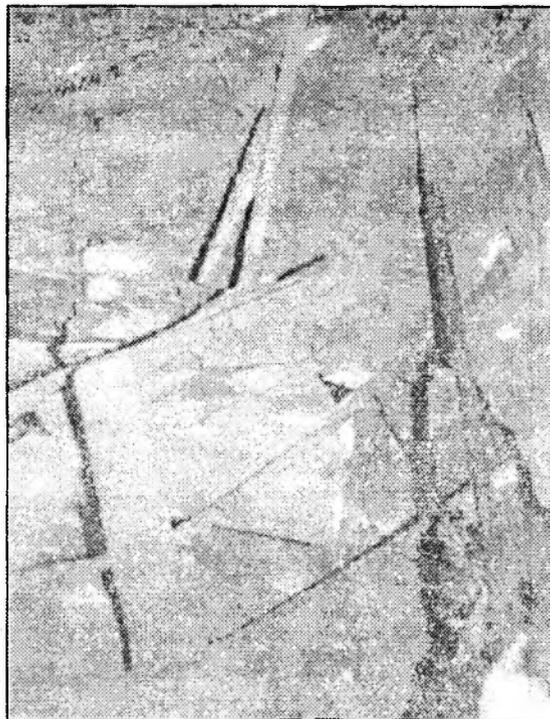
Figure. 4

“Kink zone” : From the exposed roof strata of working section, when-ever coal is left, failures of roof is observed on one side of the gallery (Fig. 4) Krausse et al. (1979) used the term “Kink Zone” for narrow zones of compressional cracking and sagging which develop in the immediate roof after mining. “Kink zones” most commonly develop on one side of the gallery or near the center line. Lateral stresses buckles the roof layers downward and jams their ends together. Some lithologies are more susceptible than others in development of Kink zones. It is observed that the “Kink zones” are not following any particular direction. It is found both in level galleries and dip galleries Kink Zones resulting into failure of roof. Hence, the support provided is becoming ineffective (Fig-5).

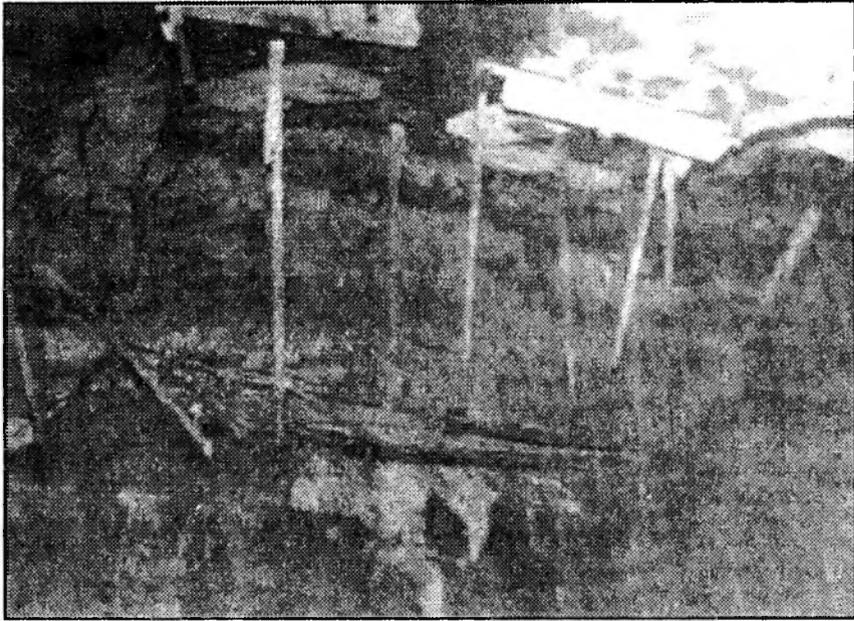
Fig. 5 - "Kink Zone", the causative factor of failure of coal roof and resulting the roof bolts as ineffective.
Location-28LN/6D.

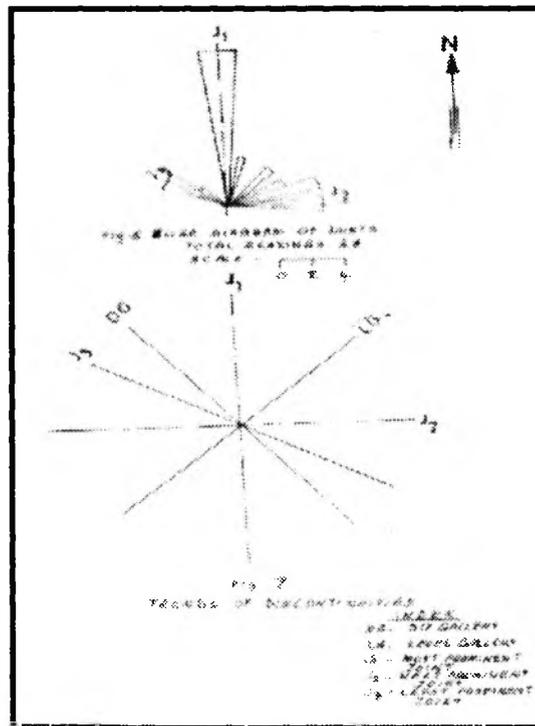
Fig. 6

About 48 joints are mapped and their rose diagram is shown in Fig.-6 which indicates that most prominent joints are trending in N-S direction and next prominent joints are in E-W direction. The least prominent joints are in the direction of N 60° W. All these joints are sub vertical to vertical tight joints and with a spacing of 0.50 m. to 2.0 m. The trend of the level galleries is in N 50° E and dip galleries are in N 40° W (Fig-6).
