Geotechnical Problems Encountered in the Penstock and Powerhouse Components of Kuttiyadi Additional Extension Scheme, Kozhikode District, Kerala

*Srinivasan, R. and Thanavelu, C.
Geological Survey of India, Chennai, Tamil Nadu*

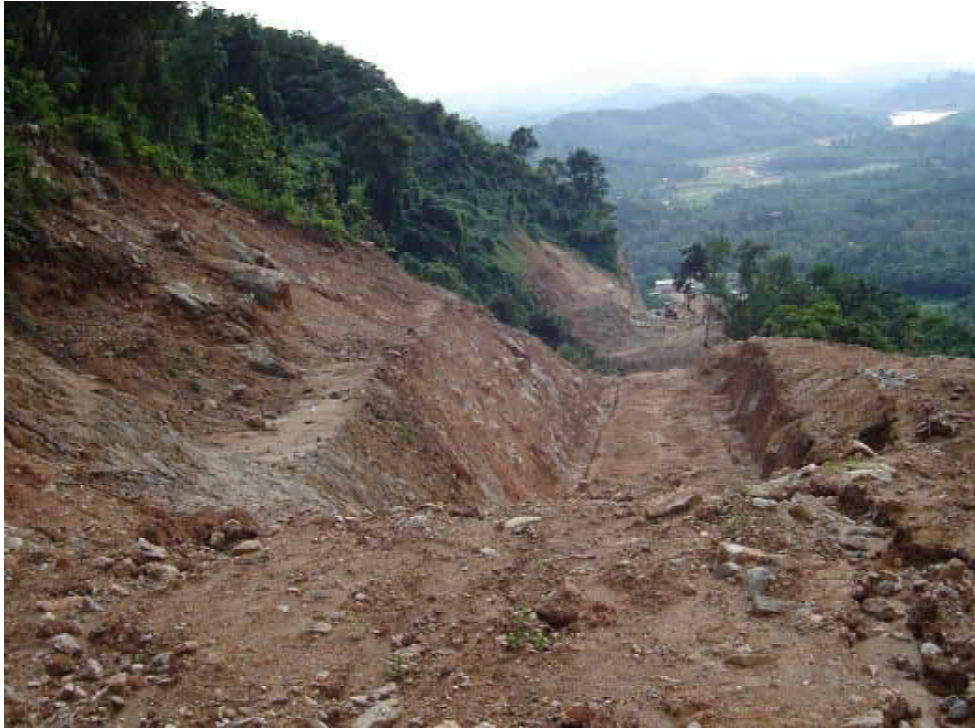
4m to 26m. Hence GSI recommended the determination of bearing capacity of the materials for founding the anchors in overburden. The proposed alignment of penstock is to be located on the side slope of the ridge, hence stability considerations were raised by GSI, and recommended pressure shaft instead of Penstock. But, project authorities (KSEB) have preferred the surface penstock. Boreholes have been drilled on the anchor block locations and additional bore holes were also drilled in between anchor locations. The area is also slide prone (picture 1) with active and dormant slides and one slide (Konipara slide) took place even during construction and particularly the Anchor blocks 13 to 17 are located on the vulnerable slope.

Picture 1 Excavations for Penstock track on a slide zone.

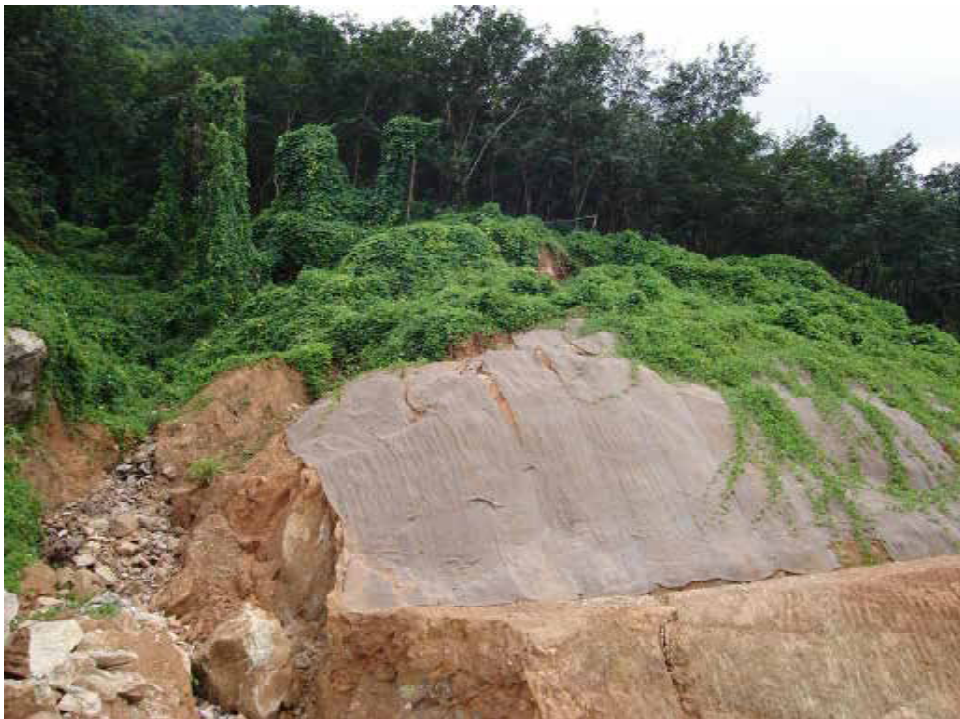
Just 25m D/S of 13A weathered rock with thin soil cover is seen. Anchor block 14 and 14A are located on rocky ridge and weathering is feeble to moderate. The slope forming material of anchor block location 15 (AB15) is made up of clayey silt, lateritic clay, micaceous and completely weathered rock (palaeo slide debris - though stabilized). Rubber plantations are there. The material has shown signs of distress and failed in the 2006 monsoon in spite of giving protection by geotextile (picture 2).

Picture 2 Failure of slope stability measures on the penstock route

Hence in view of the above, it is recommended that at the location of the Anchor blocks 13, 15, 15A and 16 where the thickness of the overburden is high and old slide debris is predominant, it is to be ensured that the load of Anchor blocks is to be transferred to the insitu hard rock whose depth is inferred from bore hole so that the stability and safety of water conductor systems is ensured. In addition temporary slope protection measures are also to be provided during excavation.

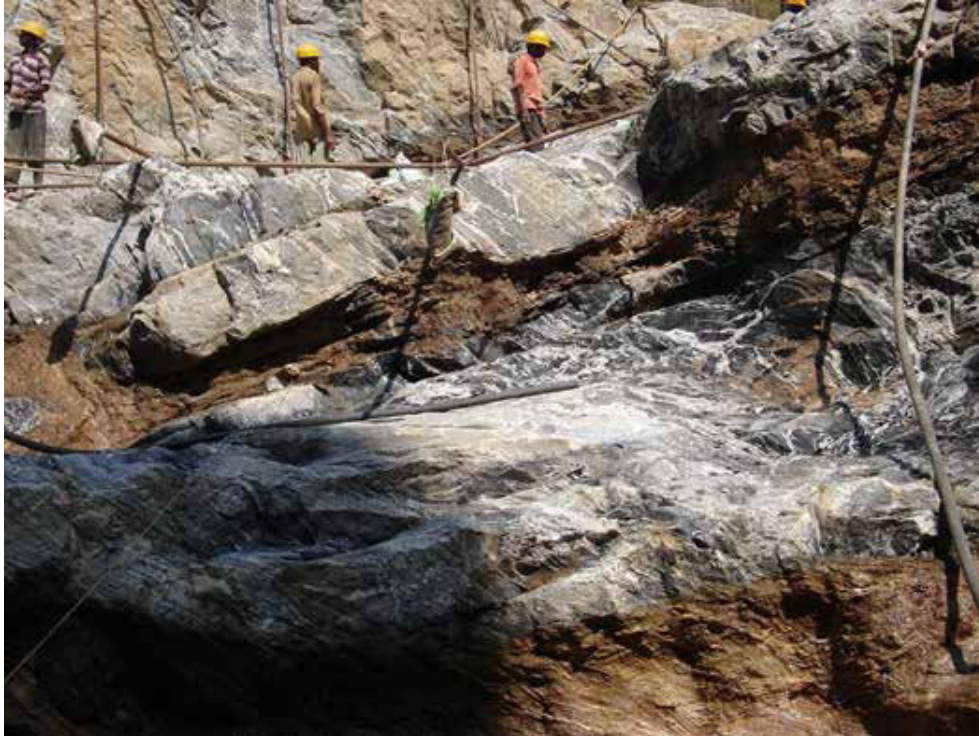
The weathered seams exposed on the walls of the Column pits and Machine pit areas show the differential weathering along the strike and dip direction resulting in non-uniform thickness from upstream to downstream direction (picture 3). The intensity of weathering also varies from place to place. Its nature varies from close spaced fracturing to completely weathered rock and clayey soil. (The seam materials were of clay, sandy clay, and sand with rock particle etc (complex nature). These multiple weak zones may act as destabilizing factor in the column foundation considering the significant design load (nearly 1000 tones per Sqm.). Hence it has become essential to ascertain the exact depth and nature of weathered seams (below the design foundation level) and thickness, fresh rock in between the sub-surface seams, etc.

The Machine pit area has also indicated the presence of weathered seam at El. 80.23 m to 79.43 m. The nature of the weathered seam varies from rock pellets to rock powder and clayey silt. The bore hole, drilled earlier, and the two confirmatory bore holes carried out presently, established the presence of weathered seams at different levels in the foundation medium throughout the sub surface area of machine pits. In order to consolidate the rock mass and to overcome the unequal bearing capacity of different strata at the sub-surface of machine pits the following remedial measures were suggested. For the entire machine pit area, consolidation grouting, down to the El.76.00 m from the present floor level with 3 m spacing, which are staggered evenly, is to be carried out in 3

Picture 3 Power house excavations exposing the subsurface weathered seams within the hard rock in the Machine bay area.

After studying bore hole cores (solid rock and loose materials) discussion was held with project authorities to arrive at the founding level of various column footings considering the geological nature of various strata and the maximum possible load and pressure that is expected to come under footing of various PH columns. To know the groutability and permeability of the weak strata at the elevation of the seam tests were conducted at select places. The results indicated that most of the seams took significant grout intake and post grout permeability was also low. After analysing all the data, founding levels of columns and necessary measures to improve and strengthen the weak strata underneath, such as consolidation grouting, were decided.

m stages. Provision should be given for grouting by leaving pipes while laying the leveling course concrete. The foundation anchoring/bolting is to be carried out to tie up or stitch the rock mass of weathered seams sandwiched between the fresh rocks to the fresh rock at a level of 8 m from the present floor level. The anchor rods of suitable thickness may be given in staggered fashion and grouted. In the machine pit area, each row should have minimum of 3 anchors with spacing of 3 m. The anchoring has to be invariably done before pouring the leveling course concrete.
