Post construction stage geotechnical investigation on Adavinainarkoil reservoir, Tirunelveli district, Tamil Naidu

*Dr. K. Jayabalan,
Director, State Unit: TN & P., Geological Survey of India,
Besant Nagar, Chennai – 90.*

*S. Chandrasekaran
Geologist, State Unit: TN & P., Engineering Geology Division, Geological Survey of
India, Besant Nagar, Chennai – 90.*

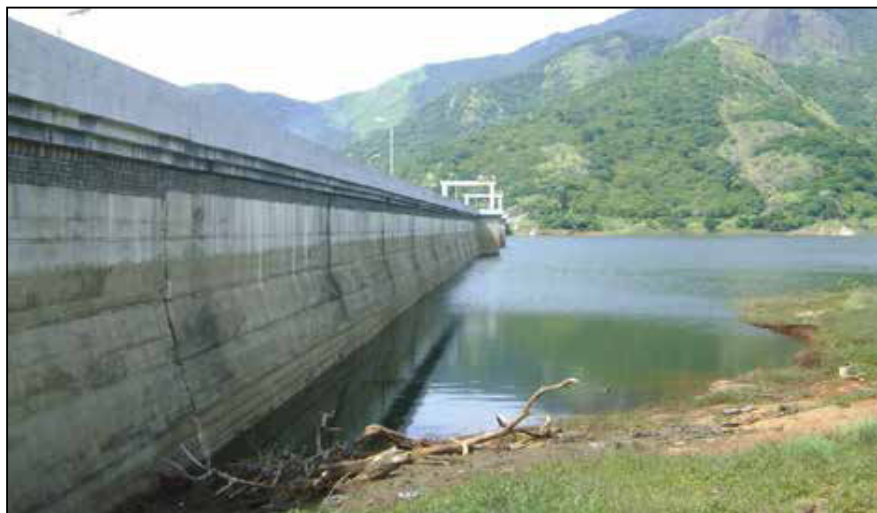
Picture 1 A panoramic view of the Adavinainar reservoir (upstream)

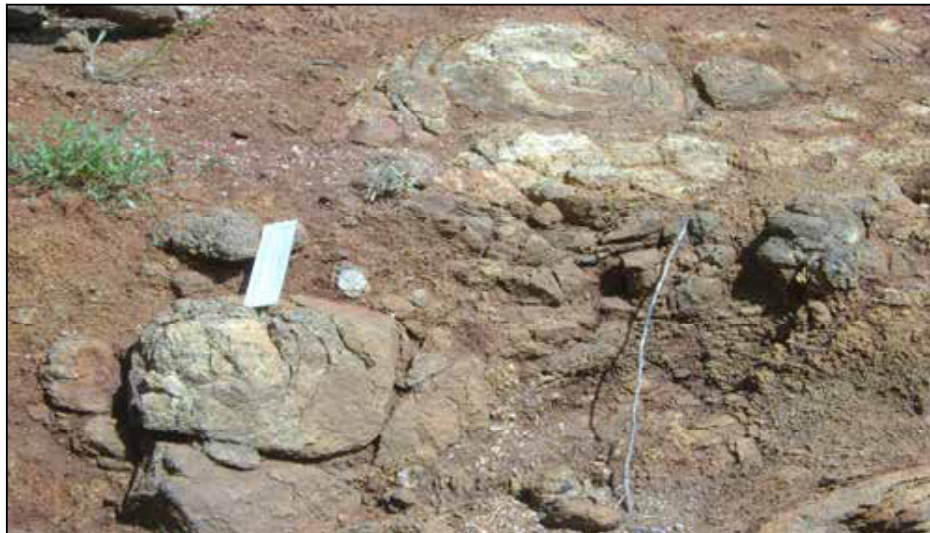
Charnockite / migmatite with linear stringers of pyroxene granulite are the prominent rock type present in the dam site (Balasubramanian-1999 et al). Mafic rocks occur as enclave, traversed by granite, pink pegmatite and quartz veins. The pyroxene granulite exhibits spheroidal weathering, at places (Picture 2). The migmatized derivative of biotite gneiss/granite gneiss shows more intensity of weathering.

Picture 2 Pyroxene granulite exhibiting spheroidal weathering (downstream)

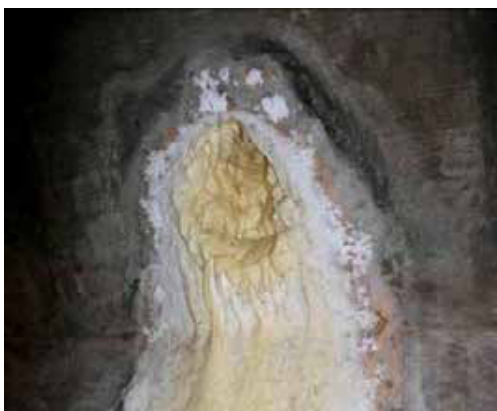
Picture 3 Drains choked with calcinations

The “V” notches and piezometers provided in the galleries are not functioning. The drains in the drainage galleries are filled with heavy calcinations (block 7, 8, 9 & 18). Ingress of the water into the drainage gallery by piping is observed d/s face of block No.22. (Picture 5)

Most of the vertical drainage shafts are chocked due to heavy calcinations. Along with calcinations Iron stains and red/yellow precipitations are also observed at place, recommended for reaming to release pore pressure. The toe drains provided with the drainage galleries got silted up with heavy calcinations (calcinations observed in the d/s phase of block No.7, 8, 9 & 18). Water seepage with heavy pressure observed in the d/s phase of block No.22.

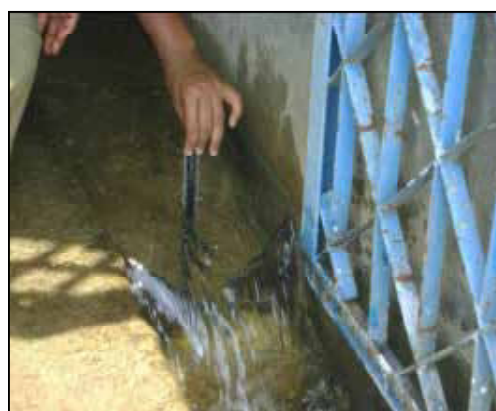
The dam has been provided with drainage gallery of standard size and shape at three different elevation levels. There are 26 blocks of different length and size, each block joint had been provided with “V” notches to measure the seepages. Transverse drainage galleries provided with pressure gauge meter. In the lowest gallery at El 210.6, the vertical drain shaft hole No 60, 61 & 63 water jet was observed. The flow may be in order of >1000 lpm, requiring immediate attention. Besides, examined the present status of the drain shafts located in the drainage galleries, most of them are choked due to heavy calcinations (picture 3). At places, along with calcinations iron stains and red/yellow precipitations were also observed. At the exit No 3 from the left end, seepage water flows above the “V” notches (>17cm) (Picture 4), depicts that the seepages are abnormal with the corresponding reservoir level of 115.25 m. If the reservoir is full, than the amount of seepage will be multi fold. Particles like sand and gravel are also noticed in the drainage chute near the “V” notch (exit No 3) warranting immediate rectification (Jayabalan et al 2009).

Picture 4 Seepage water flows above V-notch

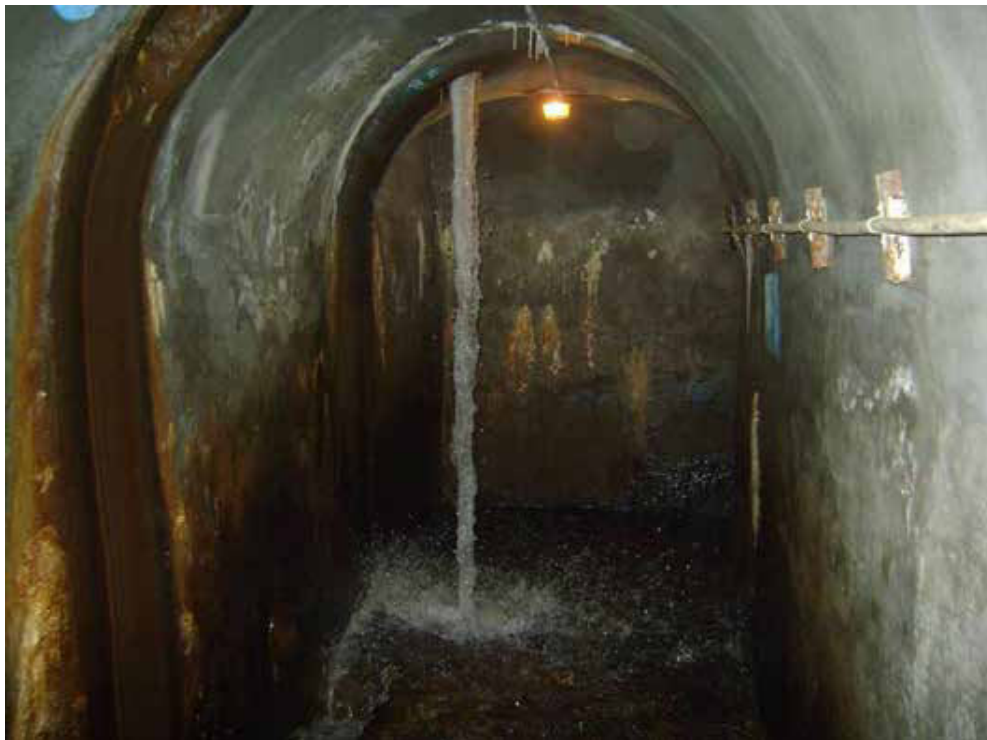
Picture 5 Ingress of the water into the drainage gallery by piping
