Engineering geological considerations during construction stage of a Bridge- A case Study of Pannar Bridge, Moghul Road, J & K

L. N. Sharma

Abstract

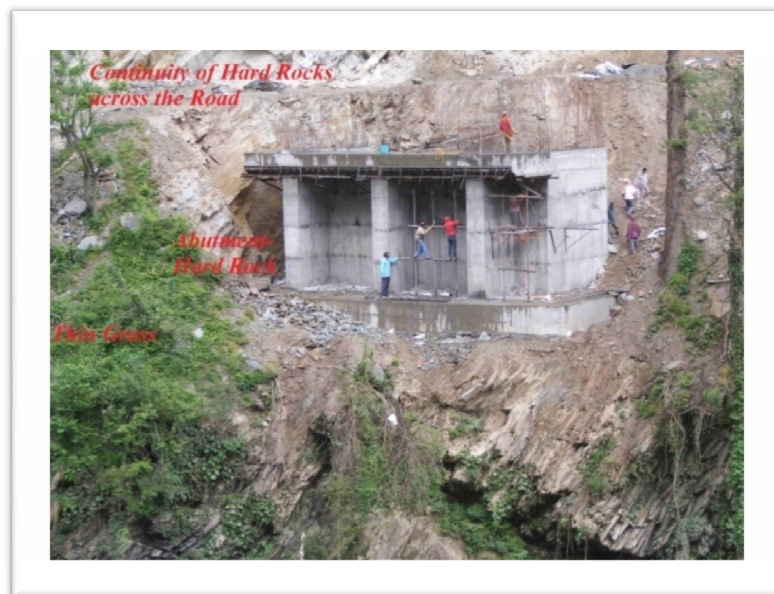
The visual reconnaissance included regional and local geology settings, tectonic setting, lithology (rock types) of the location. Topographic details and other pre-existing information supplied were verified at the site. It was observed that abutment on the Srinagar side at Pannar is placed on the hard rock after cutting rocks vertically down almost 6m from the road side leaving weak terminal exposed rocks towards river side as untouched as shown in picture 1. The base of the abutment is comfortably placed at 9m above from the river bed as shown in photograph 3. Rock faces exposed on the western side i.e. towards river side clearly shows jointed and fractured nature of the rocks. Two prominent features i.e. yellow tinge on the exposed rock surfaces and grass was found to be present wherever jointed or fractured rocks are either directly exposed to rain water, exposed to atmosphere and water coming down from high regions due to sloping nature of the strata. The yellow colour is attributed to presence of iron in the parent rocks and reaction with water for prolonged period of time; thus colouration takes place. Grasses are seen grown only on the jointed / fractured rocks having either direct contact or indirect contact with water.

Picture 1 Field Photograph of the raft foundation on Srinagar side, Pannar Bridge

Grasses were found to be absent on either barren rocks having less slopes or devoid of any soil cover. The strike of the rocks runs across the river and rocks are dipping in the north direction (picture 2) with dip angle ranging between 35 to 45 degrees. Picture 1 is showing rocks dipping in the north with fissures and joints. It also shows prolonged exposed jointed / fractured rocks broken from main body of the rock strata.

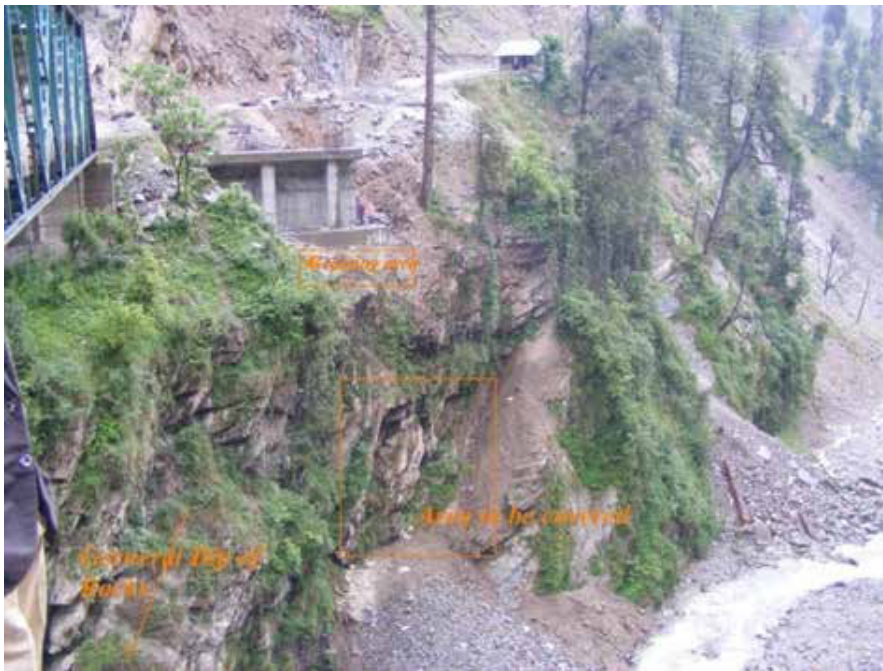
No ground water is encountered in the area while drilling till the depth at which abutment is laid down and in the field also no evidence was found. Highest flood static level is only up to 2 meters from the current level of flowing water (picture 2). Thus, no danger is anticipated to the foundation site as far as groundwater is concerned. Scouring pose no problem in this area since it is not constructed across water ways and is placed on very safe height from the river bed.

Picture 2 Site showing spot needing grouting and concrete cementing

- i) To seal open discontinuities i.e. joints and fractures and other openings in the host strata below the abutment curtain grouting need to be done through drilled holes under pressure as earmarked in figure 3. This will greatly improved / overcome characteristics of the mass and geological defects in foundation beds. Grouting will consolidate loose rock in the foundations to control uplift and pore pressure in rock slopes. This will increase the bearing capacity and stiffness of the rock mass.

- ii) Although joints / fractures made rock mass of the Pannar site facing river side appear weak, deformable and permeable, it is recommended to construct plain cement concrete structure as shown in the photograph 2. It should be planned in such a way (3-4 meters rectangular shape) that it covers exposed broken rocks and thereafter it should act as a single unit with main strata.
- iii) In order to strengthen vulnerable right side of the bridge where a tall tree is seen (photograph 3) rock bolting comprising two rows of 2 meter centre to centre and 2.5 meter deep must be carried out. The second row holes may be staggered with respect to first row. The location of bolting is earmarked in photograph 3.
