Elachi Khola Landslide Complex, East District, Sikkim - A case study on the text book type landslides

Abstract

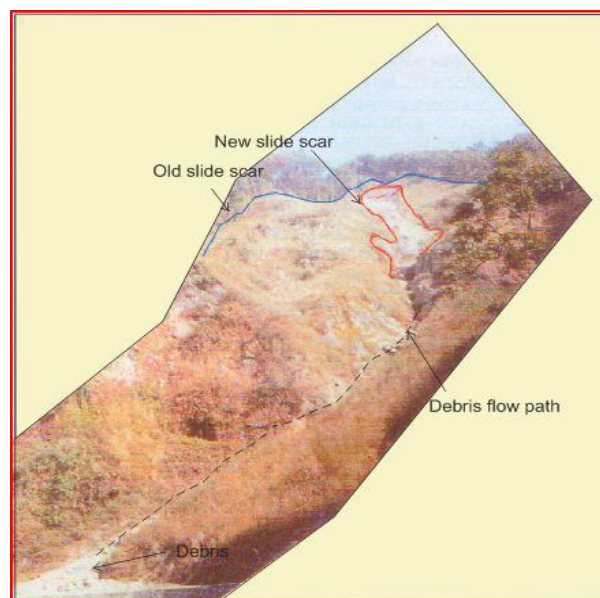
Picture 1 Main Rock slide

The main rock slide is located at the central portion of the area (figures 1 & 2). The rock slide initiated in 1984 and its activity continued since then (picture 1). The slide probably activated in an old slide scar. Tall vertical trees are found to occur beyond the rim of the old slide scar. The area between old and new scars is covered with grass and shrubs as big trees are not supported in rocky slope due to removal of soil cover during old slide event. The upper limit of old slide scar reached upto EL 840m i.e. about 310m above the road bench. The crown of new slide reaches upto EL 825m i.e. 295m above the road bench. The surface of the old as well as new slide scar is entirely rocky consisting of phyllites, quartzites and quartz-sericite schist.

The present slide activation zone is in between 245m and 295m above the road Bench (EL 775-825m) and debris comes down through a curvilinear and zig-zag path on and

below the road bench. This zig-zag and curvilinear path has resulted due to protruded competent rock mass (e.g. quartzite) present along the debris flow path, which represents the locus of the head ward movement of the present slide. Due to the debris flow, erosion of the rock outcrops has resulted in development of some small rock slides on both sides of the debris flow path.

The main causative factor of the slide is failure of wedges formed by intersection of major joint sets. The failure is aggravated by percolation of water through joints as evidenced from openness of the joints, stained joint planes and presence of few seepage points in this zone. Weathering along the joints especially in phyllite indicates percolation/flow of water. Consequently, the shearing resistance of the rockmass along joints reduced during saturation resulting in failures. It is also found that the spacing of foliation joint is very close in phyllite in comparison to those in quartzite and quartz-sericite schist. As a result, the wedges of quartzite and quartz-sericite schist are larger than those in phyllite.

Failure of wedges formed by vulnerable joints is the main factor of slides and slope failure. Protection is required at the crown portion (245m – 290m above the road bench) from where major sliding is taking place. Owing to failure of smaller wedges wire mesh shotcrete appears to be effective. However, rock bolting in the quartzitic rock is required where larger wedges are being formed. The angle and direction of the rock bolts as worked out earlier is 40° N20°W. Surface and seepage water also play an important role for activating the slide by reducing the shear resistance along the joints and by eroding the softer/weathered rock mass (phyllite) present at the active slide zone as well as along the debris flow path. Contour drains above the crown of the slide are required to drain out the surface flow and to minimize the percolation/ infiltration. Draining out of subsurface water is also required to reduce pore water pressure and to prevent erosion of finer particles. For this purpose perforated pipes filled up with filter material are to be inserted into the rock mass for about 3m depth with an inclination of 15° with the horizontal considering the smaller size of wedges. To prevent erosion along the debris flow path a concrete chute is preferred.

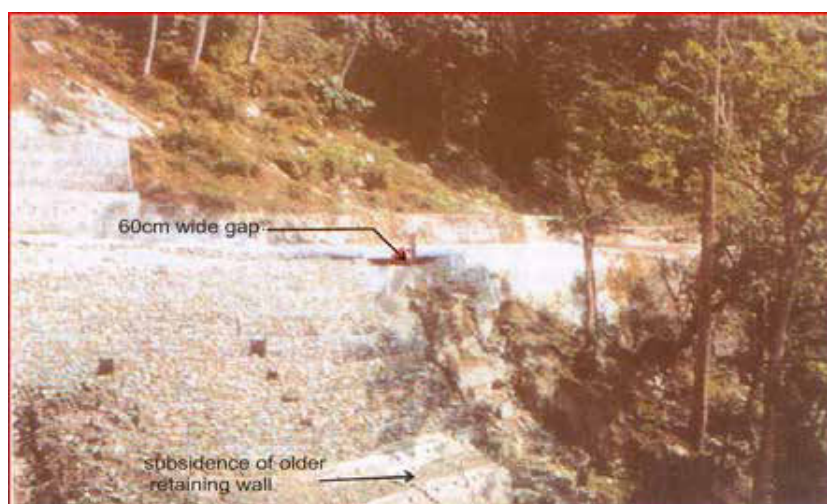
The sinking zone is located east of the rock slide zone, i.e., towards Singtam side (figures 1 & 4 and picture 2). Elachi Khola flows along the northern boundary of the sinking zone. A perennial nala fed by ground seepage marks the southern boundary of this zone. Further south, rock is exposed at the edge of the road bench. Gradual sinking/subsidence and creep movement of the ground including the road bench is a common phenomenon at this site especially during rainy season and has left the imprints of successive damages on the retaining structures both above and below the road bench.

Picture 2 Sinking zone showing subsidence gap (60cm) between the retaining walls and concrete causeway and subsidence of old retaining walls.

Though the area is covered with old slide debris for considerable distance towards Singtam, but the most affected zone is about 60m wide along the road bench. This is because the rocks are exposed south of the sinking zone, form the toe support of the overlying debris preventing subsidence/ sinking. The slope of the sinking zone is gentle (10°-25°); however, higher slope (35°- 40°) is present at the lower reaches i.e from road bench to 45m in the upslope direction. At the gentler slope, step cultivation is observed. The old slide debris consists of varying sizes of boulders including exotic blocks in a sandy to silty clayey matrix. Probably concentrations of these huge boulders have made the slope steeper near the road bench. A few 1-2 m thick shear zones (N70°W-S70°E/85°SW) have been observed on the road cutting slope at the rock outcrops beyond the southern boundary of the sinking zone. As the attitudes of these shear zone are tentatively matching with the scar of the old slide, there are chances of presence of a major shear zone in the debris laden sinking zone. The old slide debris may have resulted due to sliding along the above major shear zone. A number of seepage points have been observed above the road bench. It indicates presence of impervious soil at a shallow level as rock is not expected upto a considerable depth. Three soil samples have been collected; these pertain to disturbed washed out samples (E1) derived through the seepages, the sample E2 is from the sinking zone away from the seepage points and sample E3 from the seepage points. The samples E2 and E3 are taken from 10-30cm depths. The determined physical properties of the samples are given in Tables – 3 & 4. The washed out sample (E1) represents the transported material from the old debris through seepages. It contains mainly silt (59%) with about 4% clay belonging to ML group, indicating low compressibility clay. The E2 and E3 represent the debris material and belong to GW group. Whereas, E2 comprises mainly sand (89%), with little amount of silt (10.5%) and negligible clay (0.5%) indicating very high permeability, E3 contains mainly gravel and sand (~86%). However, finer fraction of E3 represents MI group of soil containing silt (~15%) and clay (~0.7%). It indicates intermediate plasticity silt and high permeability. It is anticipated that finer particles like silt and clay fractions from E2 and E3 are removed through piping along with seepage water. Owing to removal of finer particles from the top layer of soil it has a higher permeability. The clay present in the sample is about 0.5% and devoid of swelling nature. Thus, it is not likely that sinking/subsidence has resulted from the swelling of clay present in the old slide debris and due to piping of finer particles (silt and clay) caused by sub surface flow during super saturation.

Prima-facie, the cause of sinking/subsidence of debris material is removal i.e., piping of finer particles through sub-surface flow. Prevention of migration/removal of finer particles as well as subsidence could be checked by providing a series of contour trench drains in the sinking zone filled up with filter material. The seepage water may be channelized from these drains to both Elachi Khola and the nala fed by seepages located to the north and south of the sinking zone respectively (fig.- III). Besides, a few benches may be provided with sausage breast walls to ease out the slope.

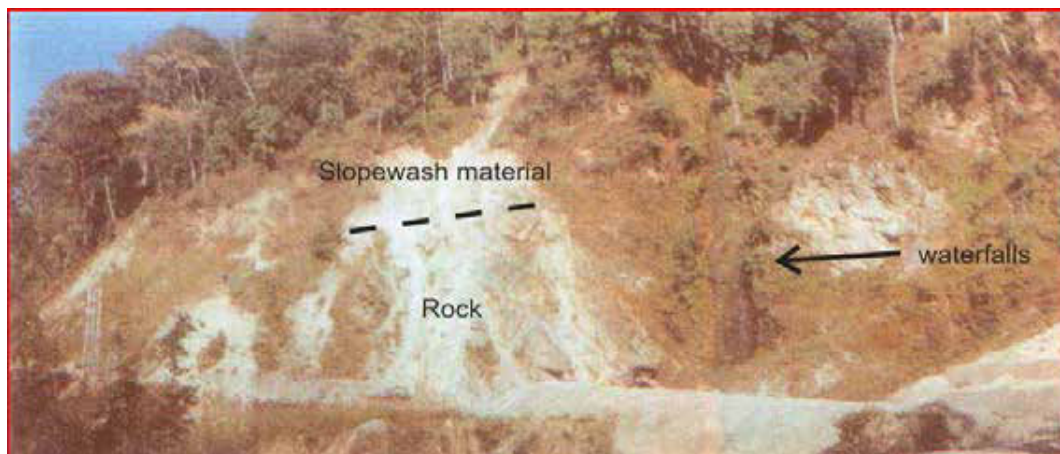
There is a nala with a small waterfall at the western side of the main rock slide (figure I and picture 3). Due to high discharge of the perennial nala during monsoon, boulders from the nala bed roll down on the road bench. Generally, the nala has a steep gradient; at few places, gentle gradients are also observed, e.g., just above the waterfall.

Picture 3 Rock cum debris and Boulder shooting along waterfalls

The nala bed is rocky with thin veneer of nala deposit (pebbles and boulders) for a considerable distance in the upslope direction at least upto the crown of the rock slide zone (EL 840m). The nala indicates a shift in course as evidenced from presence of a dry abundant nala located just west of it, caused possibly by erosion along weak zones/joints during excessive discharge. During the monsoon it is observed that pebbles and boulders roll down from the nala course with high velocities.

It is located to the west of the boulder shooting nala and affected about 35 m road length. The slide has initiated from the uphill slope cut face of the road bench. The height of the slide scar varies from 30-60m from the road bench, i.e., EL 560-590m (figures 1 & 3 and picture 3). At this site, rock is present below a cap of 1- 2.5m thick slope wash material. The slide initiated in slope wash material due to steep slope cuts for the road bench. The rock mass has also a tendency to slide down along unfavorably oriented valley-ward dipping joints. Steep cut slope and weathering of rock coupled with percolation of rain water are the main causes of slide.

The size of boulders is small and there is a slope break at the nala bed just above the waterfall/road bench. A boulder catcher at the gentle slope portion (above the waterfall) may be an effective remedy. Owing to small size of boulders, a wire mesh/ chain link

wire net (as used in the gabions/sausage walls) may be provided across the nala as fencing, fixing it with two RCC pillars to be constructed from the rocky banks of the nala. The wire mesh/ chain link wire net may be used as double ply to strengthen the same; it requires time to time cleaning. An RCC cause-way at the waterfall site on the road may be constructed to prevent degradation of the road bench due to incessant flow of water.

One bench with a breast wall at about 3m below the crown of the slide is proposed near the contact of the slope wash material and rock mass to prevent sliding of the former. The height of the rocky zone is less where, wire mesh shotcrete with drainage holes and a few rock bolts would be required to prevent the rockslide.

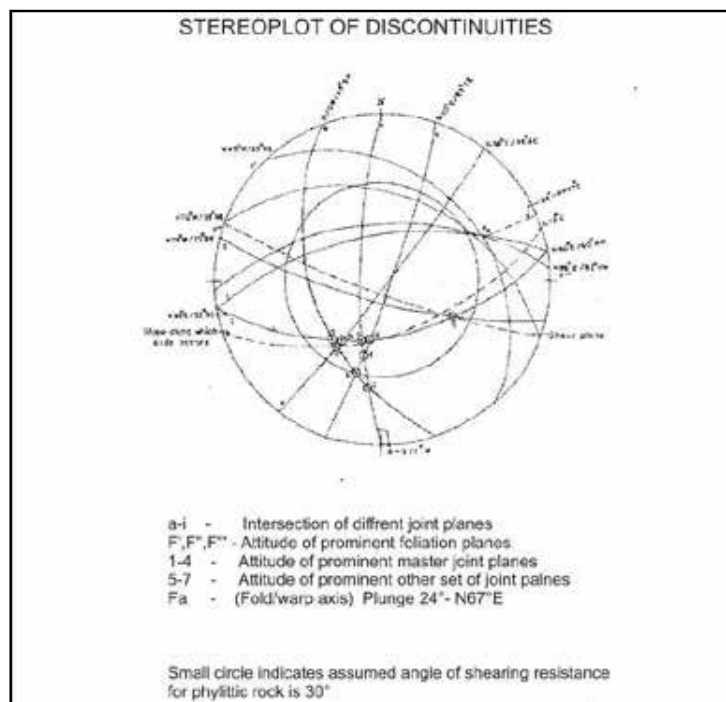
Figure 5 Stereo Plot of discontinuities

The joint data has been analysed through stereo plots. The intersections of different joints have been shown in fig.- V and vulnerable wedges in respect to slope in fig.- VI. The angle of internal friction of the rock has been assumed as 30° . During determination of vulnerable wedges the average slope of the slide face has been taken as 54° S 20° W. It is found that nine intersections plunging towards the slope closely fall within the vulnerable area. An average plane containing most of the vulnerable joint intersections has been worked out. The pole of this average plane indicates the inclination and direction (40° N 21° W) of rock bolts, suitable to stitch the joints to prevent wedge failure.
