Post Construction Stage Geotechnical Investigation of Idamalayar Hydro Electric Project Idukki District, Kerala

Abstract

Post Construction stage geotechnical investigation was taken up to assess the cause and extent of the reported leakage in the intermediate inspection gallery, near construction block joint of 15 & 16, at Ch. 436m. Initially, it was apprehended by the project authorities that the probable reason for the seepage could be the shear zone in block 16, which coincide with the fault trace in the foundation. But, the inspection of the site revealed a different picture and is dealt briefly in this paper.

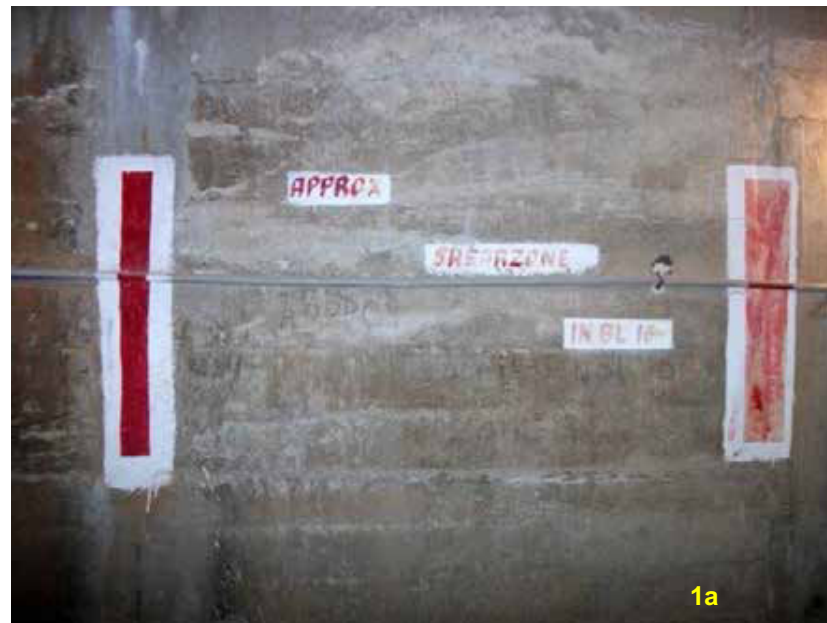
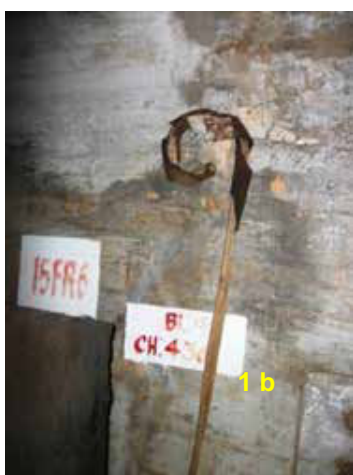
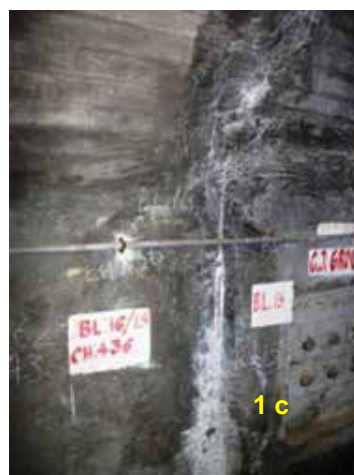
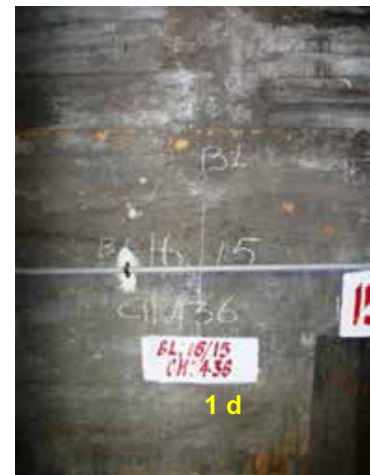
Initially, inspection was made in the lower galleries in block 15 and 16, where the shear zone was reported in the foundation. All the three lower inspection galleries (parallel to one another) and the transverse gallery were carefully inspected and no leakage could be observed in any of the block joints or in their vicinity. Inspection of the galleries, at the location of shear zone (picture 1a) revealed absolutely no seepage from the shear zone section, except from the foundation drains and the release wells. Ironically, while there is no seepage in the lower inspection galleries, above the block joints 15 & 16, coinciding with the trace of shear zone, significant seepage has been reported from the middle inspection gallery. No sign of wall deformation and development of cracks justifying differential settlements in the shear zone section could be observed. It is, therefore, evident that the reason for the leakage reported in the middle gallery is not due to the shear zone or due to any other geological reasons.

Picture 1 Photograph showing faces of different drainage galleries; a. Dry face in the shear zone in the Lower drainage gallery ; b, c, d. – dry faces of three lower drainage gallery parallel to one another in the construction block joint 15/16

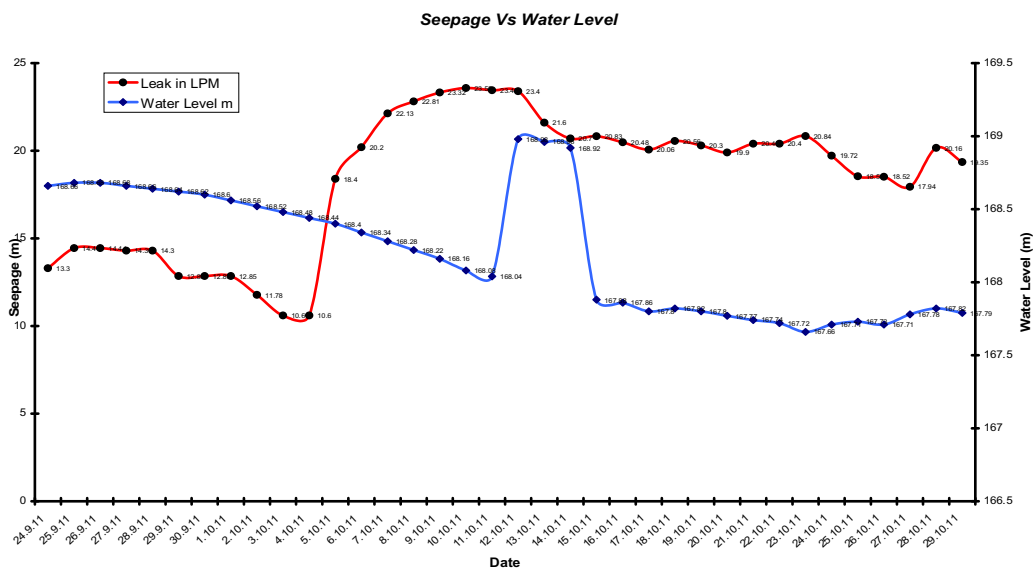
Figure1 Graph representing Leakage vs Water Level

The leakage and the dam water level recorded over a period of 36 days has been listed date wise in the Table 1. The leakage ranges between 10.6 LPM and 23.58 LPM. A graphical plot of water level Vs leakage (Figure 1) shows that, there is no correlation of leakage and the fluctuation in the dam water level. A significant observation was that, initially there was a gradual increase in seepage which came down to 10.6 LPM on

3.10.11. Suddenly, there was surge in the leakage from 5.10.11 onwards and which reached maximum (23.58 LPM) on 10.10.11, thereafter gradually reduced and stabilised around 20 LPM. After analysing the total seepage data accumulated over the years, it is observed that the maximum total seepage so far recorded is 110.54 LPM in September 1994. As against this data, presently, the total seepage is of the order around 68 LPM only.

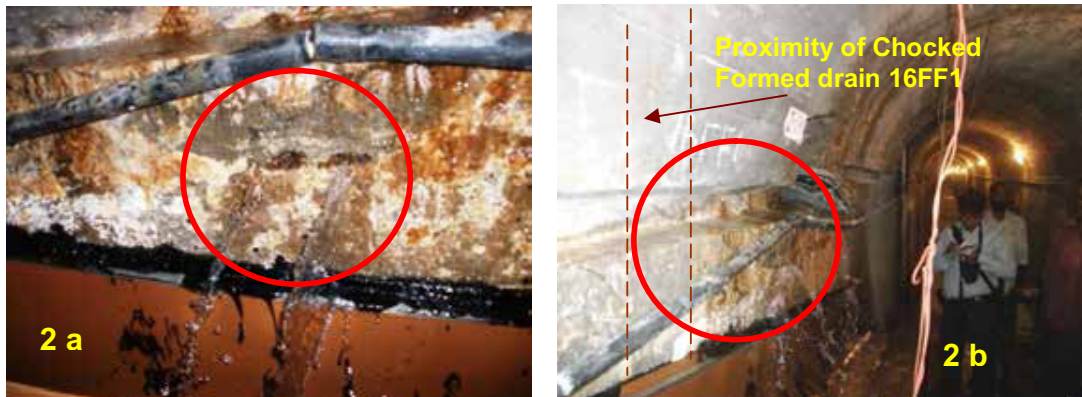
Post construction geotechnical investigation was carried for Idamalayar Dam, for the reported leakage (at ch.434m), in the middle inspection gallery, near construction block joint of 15 & 16, at Ch. 436m (Photograph 2a & 2b). Initially, it was apprehended by the project authorities that the probable reason for the seepage could be the shear zone in block 16. But, the inspection of the site revealed a different picture. The observations and inferences are discussed below.

Picture 2 Photograph showing leakage at ch.434 m in intermediate drainage gallery; a. leakage in block joint 15/16; b. Photograph showing the proximity of chocked formed drain to the leakage point in block joint 15/16

It is, thus presumed that, the copper strip provided to seal the construction joints might have corroded, giving way to the dam water to seep through from u/s face of the dam along the construction joint. Most drains got chocked due to calcinations and failed to channelise the water. Due to chocking of the formed drains, the seepage water has accumulated inside the contracted formed drains, leading to formation of local hydrostatic head. In this case, since there is a blockage, the seepage water has found its path in the block joint 15/16, in the intermediate gallery near ch.434m.

The seepage and the dam water level were analyzed and the results indicated, that the seepage stopped while the water level goes down to the level of intermediate gallery, i.e., 128.50 m. Therefore it was concluded that, the reason for seepage in the intermediate gallery is due to damage in the construction joint, between block 15 & 16 and not due to any geological factor.

It is therefore recommended to ream the formed trap drain by suitable means and to grout the leakage during the lean period, after the water level drops down, below the level of intermediate gallery level, after a careful check of the copper seal.

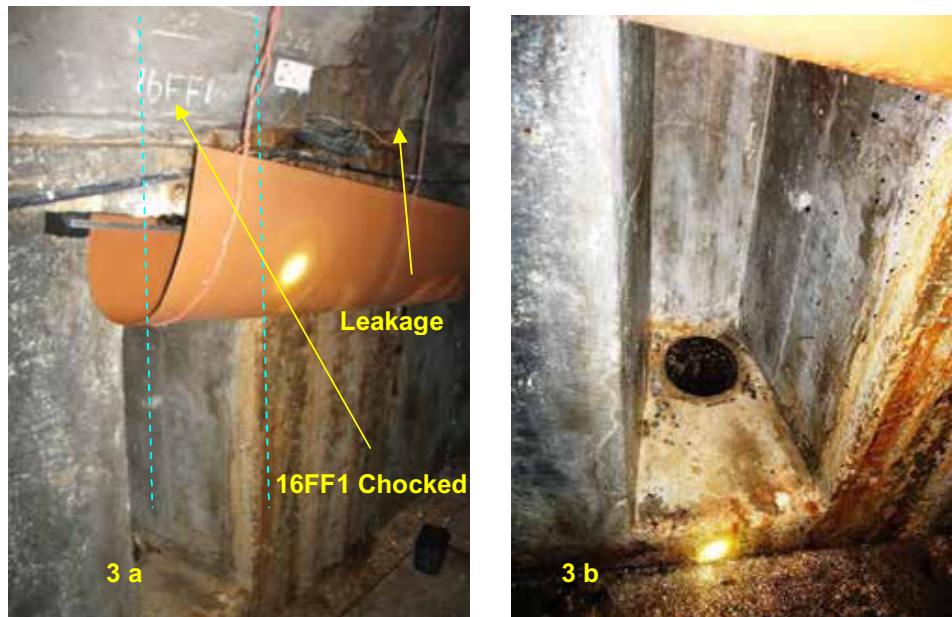
Most of the formed trap drains were found partially chocked and in some cases completely chocked due to calcinations (pictures 3a & 3b). This was observed near the block joint 15/16, viz. 16FF1, 16FF2, 16FF3 and 15FF4 and so on.

Picture 3a. Chocked Formed Drain 16FF1 opening in intermediate gallery;
Picture 3b. Leakage water could not pass further down through 16FF1 formed drain
due to chocking

No wetting or seepage has been observed in any of the faces in the lower drainage galleries. But, most of the formed drains are chocked due to calcinations. Significantly the formed drain no.16FF1 near the leakage point in block 15/16 is completely chocked at the opening in the intermediate drainage gallery. No signs of wall deformation and development of cracks justifying differential settlements could be observed, which suggests that there is no link between with any geological feature and the leakage at ch.434, in the intermediate drainage gallery and. The shear zone therefore does not influence the reported seepage, in any way. It is thus concluded that the copper strip provided to seal the construction joints might have corroded, giving way to the dam water to seep through from u/s face of the dam along the construction joint. Due to the hydrostatic head, seepage water in the chocked drain (16FF1), has found the passage through the block joint 15/16 which is in its near proximity.
