# Excavation of silt flushing tunnel (SFT) in difficult geological conditions-A case study

Thakur .S.N
General Manager (Project),NTPC Ltd, TVHPP
Prakesh .V
Addition General Manager (B&DC), NTPC Ltd,TVHPP
Pargaien .C.G
DGM (Geology), NTPC Ltd,TVHPP,
E-mail:girishcp2005@yahoo.co.in

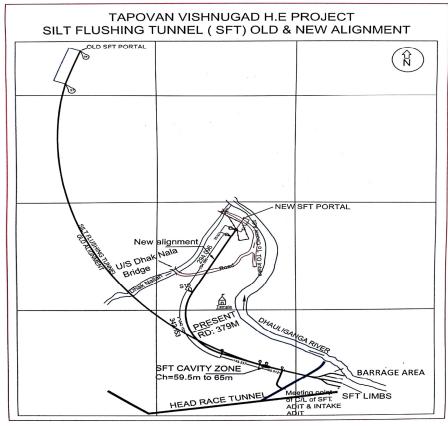
Figure 1 Silt Flushing Tunnel Alignment

In order to flush out silt from de-silting arrangement a 1465m long tunnel is under construction. Silt flushing tunnel has four limbs of different length. During design stage various alternatives for SFT was explored. Due to difficulties faced the old SFT outfall after construction of 96m was abandoned. A new out fall portal is developed before the DhakNala and 22m of tunneling has been completed in the overburden. Changing of old outfall portal to new outfall portal of SFT ismainly for time saving for construction. Main geological problems are encountered during excavation of SFT are poor rock mass conditions at SFT limbs, formation of cavity at RD 59.5m, extremely poor rock mass encountered from Old SFT out fall area, at SFT D/S right side (SPL to crown) water ingress was observed. Compacted alluvial material of various size are observed from new location of outfall portal. Layout of old and new SFT alignment is shown in fig.-1.Excavation of SFT u/s and d/s was carried from junction point of SFT & adit to SFT. In the u/s direction after 121m four number of limbs were constructed mostely in poor rock mass condition. The same was supported with steel rib's. In addition to design support additional support was installed during excavation. At the d/s of junction mainly fair rock mass condition was observed with some zones of poor, very poor and extremely poor rock mass and cavity at RD 59.5m. From the old outfall portal excavation was done in extremenly poor rock mas conditions. The same was supported by steel ribs. In the new out fall portal mostly compacted alluvia material is observed and being supporeted with steel ribs.
