Landslides Management in Rural Roads in Regions of Kotdwar in Pauri District (Uttarakhand): Challenges & Opportunities

Shakti Prakash
Environmental Specialist, URS Consulting Pvt. Ltd, Gurgaon, Haryana
V.V.S. Gulati
Team Leader, URS-Scottwilson India Pvt.Ltd, Pauri, Uttarakhand

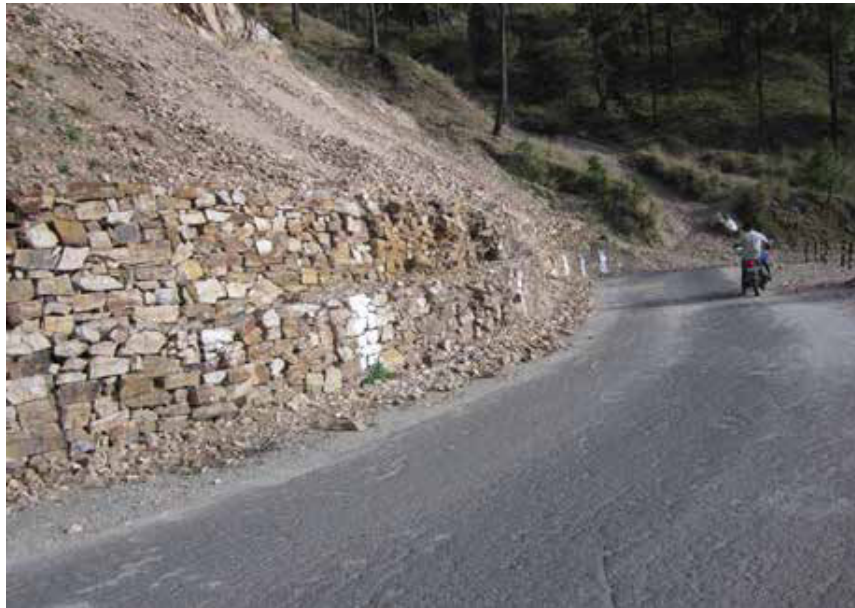
Picture 1: Wire-Crete under construction along the chainage 10 + 650Km on Kandakhal-Chailusain road

S. No.	Road	Length	Chainage of Landslide Occurrence	Mitigation Measures Taken	Photograph No
1.	Kandakhal-Chailusain	15.00 km	10 + 650	Wire crate	1
			6 + 730	Breast wall	2
2.	Matyali-Dwarikhhal	17.20 km	14 + 600	Wire crate	3
			8 + 400	Wire crate	4
			6 + 900		5
3.	Chailusain-Devikhet	10 km	1 + 950	Wire crate / Retaining Wall	6
			3 + 000	Breast wall	7
4.	Hanumanti-Fatehpur	6.00 km	0 + 650	Breast wall	8
			1 + 250	Retaining Wall	9
			2 + 050	Breast wall	10

So far only civil engineering measures have implemented, though there is a need for applying combination of civil & bioengineering measures. Majority of civil engineering measures are Bresatwalls, Check walls, Wire-Crete and retaining walls (Pictures 1 to 10).

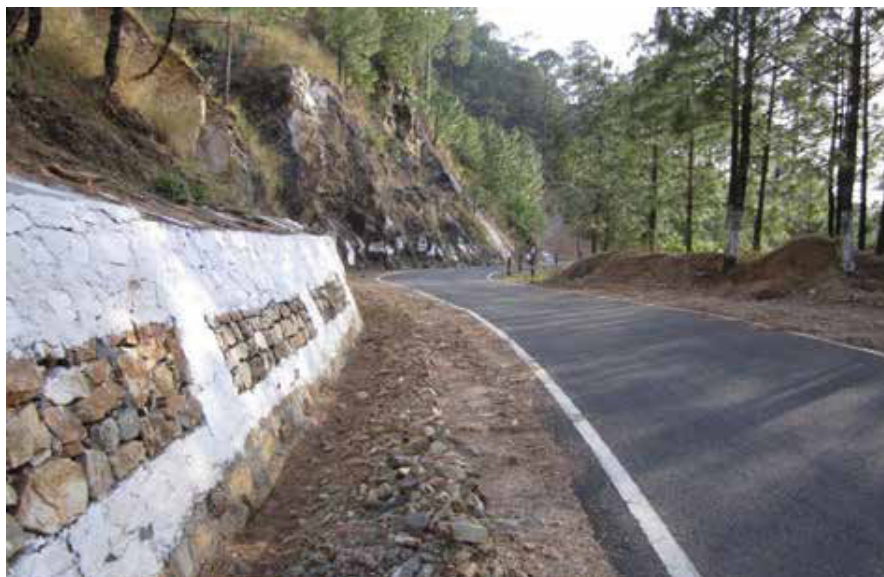
Picture 2 Breast wall constructed along the chainage 6 + 730 Km on Kandakhal-Chailusain road

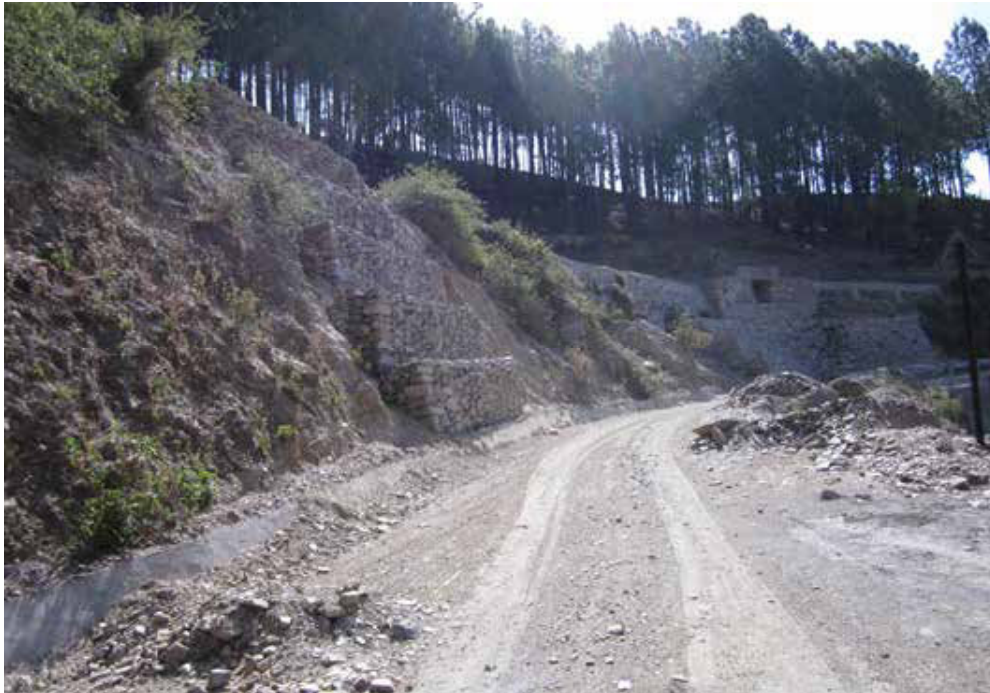
Picture 3 Wire-Crete constructed along the chainage 14 + 600Km on Matiyali-Dwarikhal road

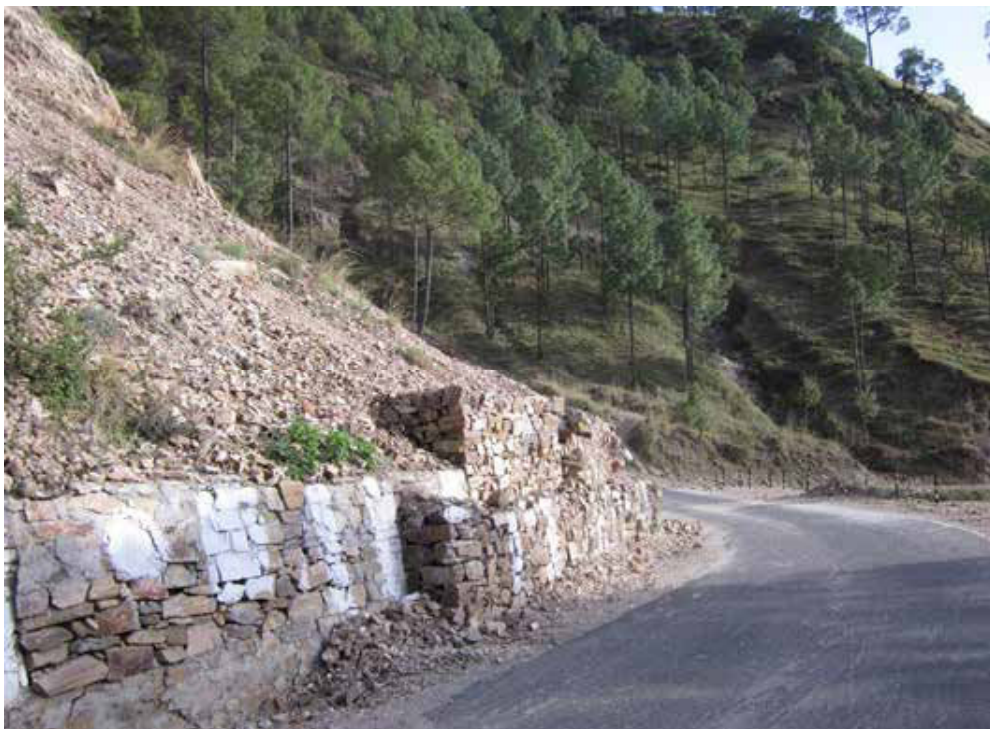
Picture 4 Wire-Crete constructed along the chainage 8+400 Km on Matiyali-Dwarikhal road.

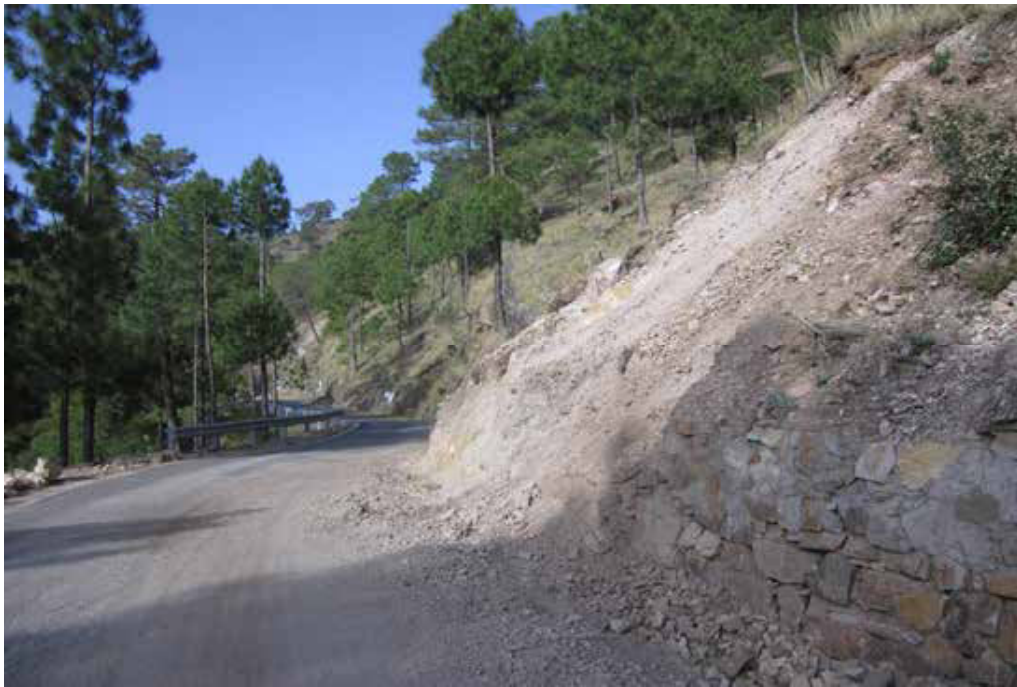
Picture 5 Breast wall constructed along the chainage 6 + 900Km on Matiyali-Dwarikhal road.

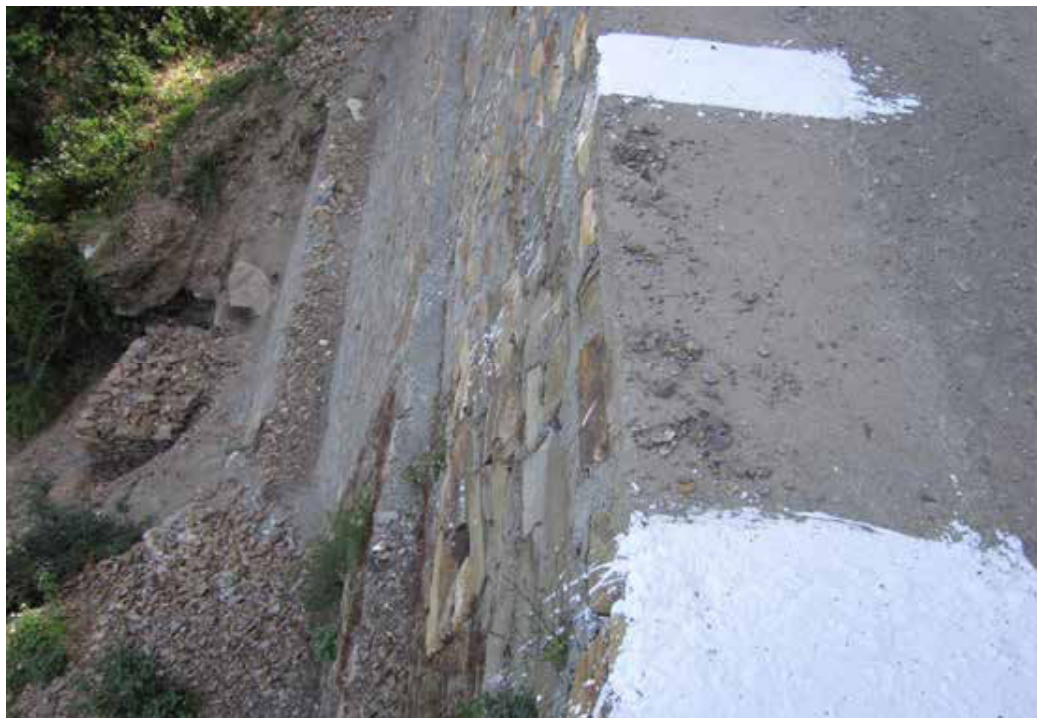
Picture 6 Wire-Crete & Retaining wall constructed along the chainage 1 + 950 Km on Chailusain-Devikhet road.

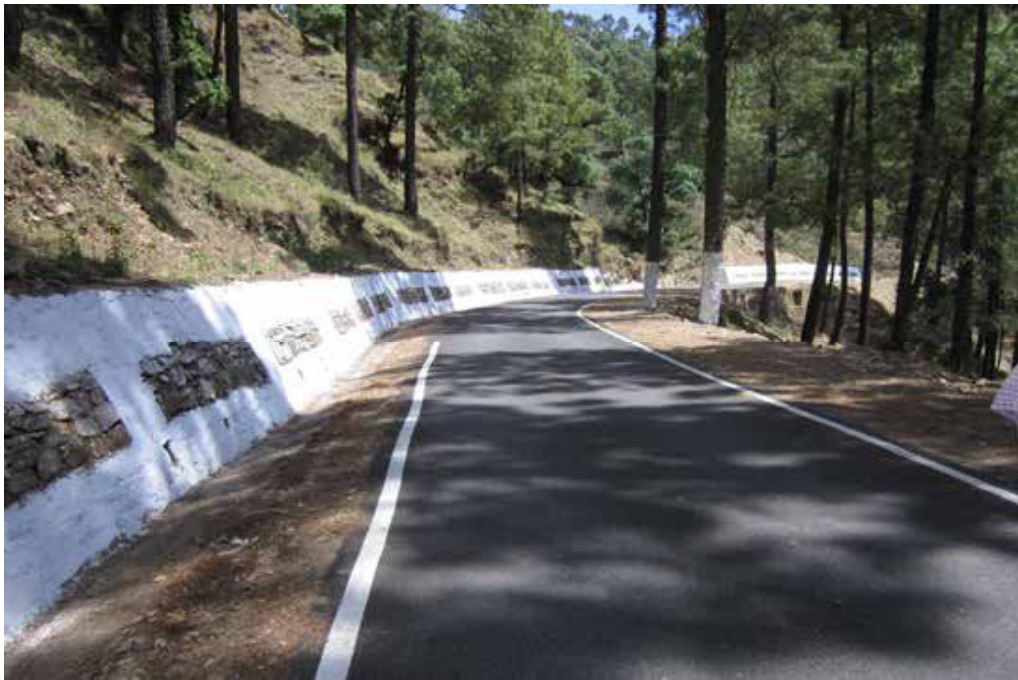
Picture 7 Breast wall constructed along the chainage 3 + 000Km on Chailusain-Devikhet road

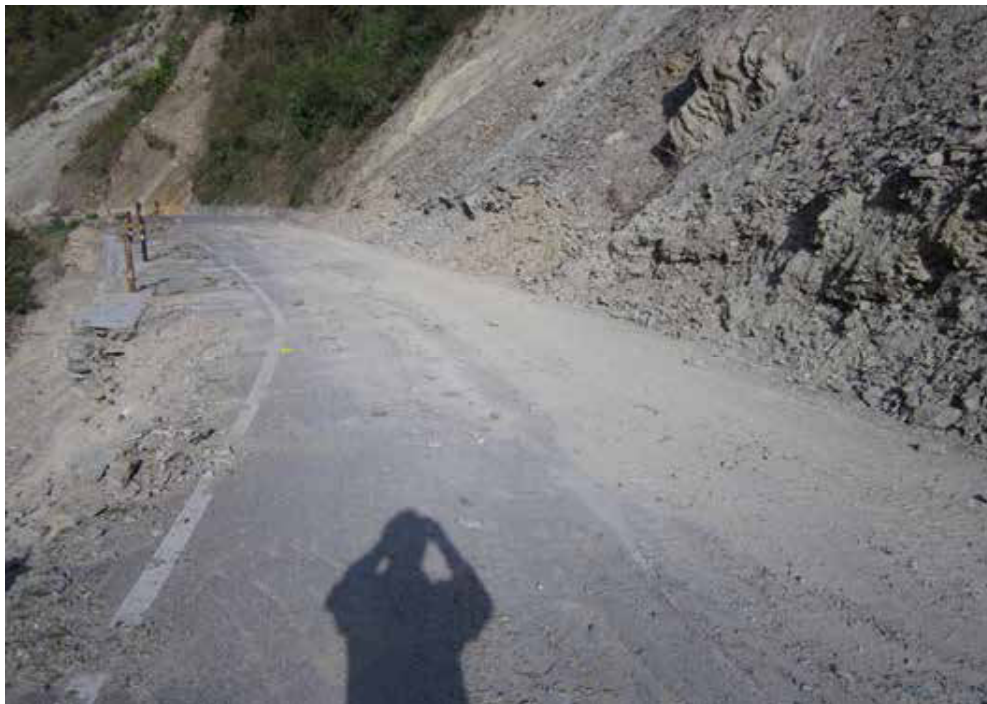
Picture 8: Breast wall constructed along the chainage 3 + 000Km on Hanumanti-Fatehpur road

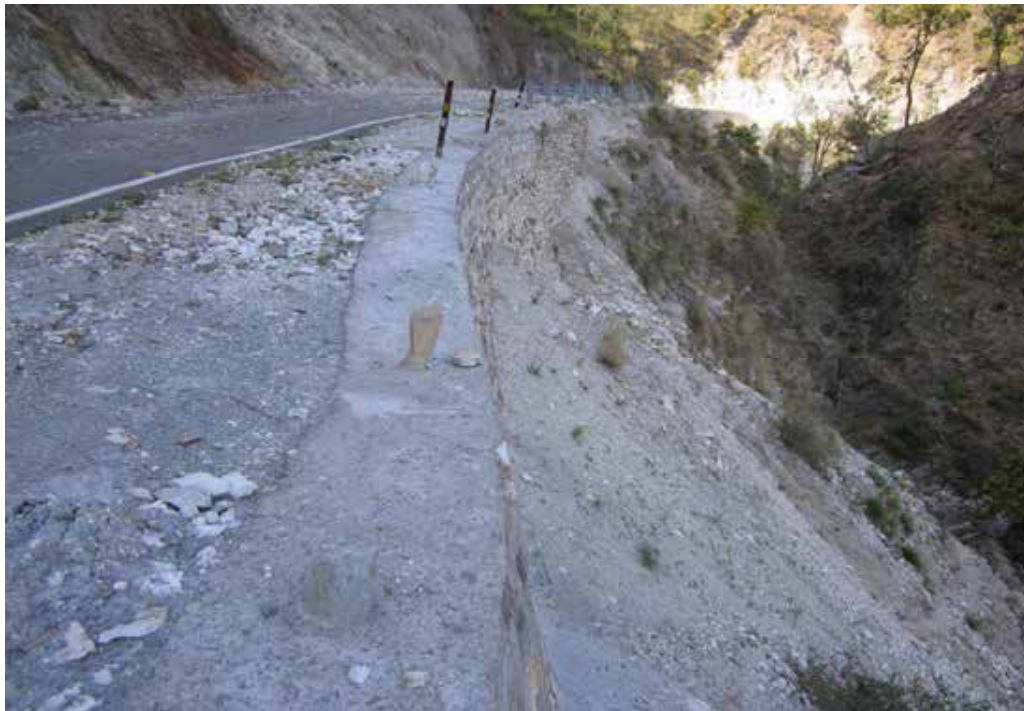
Picture 9: Retaining wall constructed along the chainage 3 + 000Km on Hanumanti-Fatehpur road

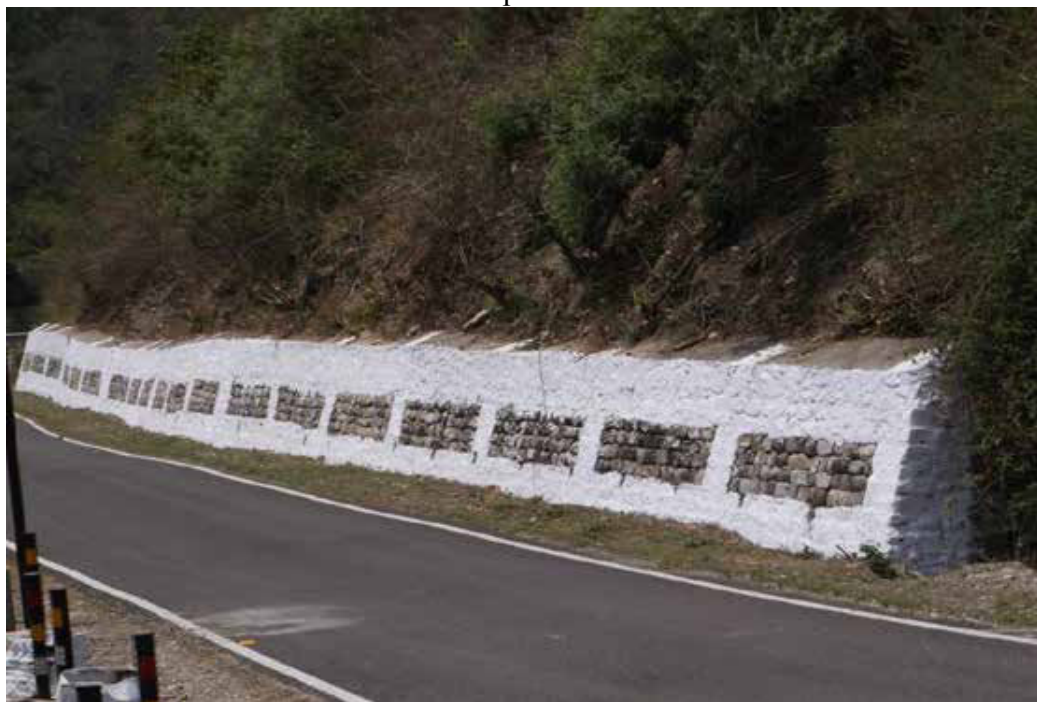
Picture 10: Breast wall constructed along the chainage 13 + 400Km on Hanumanti-Fatehpur road
