Elachi Khola Landslide Complex, East District, Sikkim - A case study on the text book type landslides

Abstract

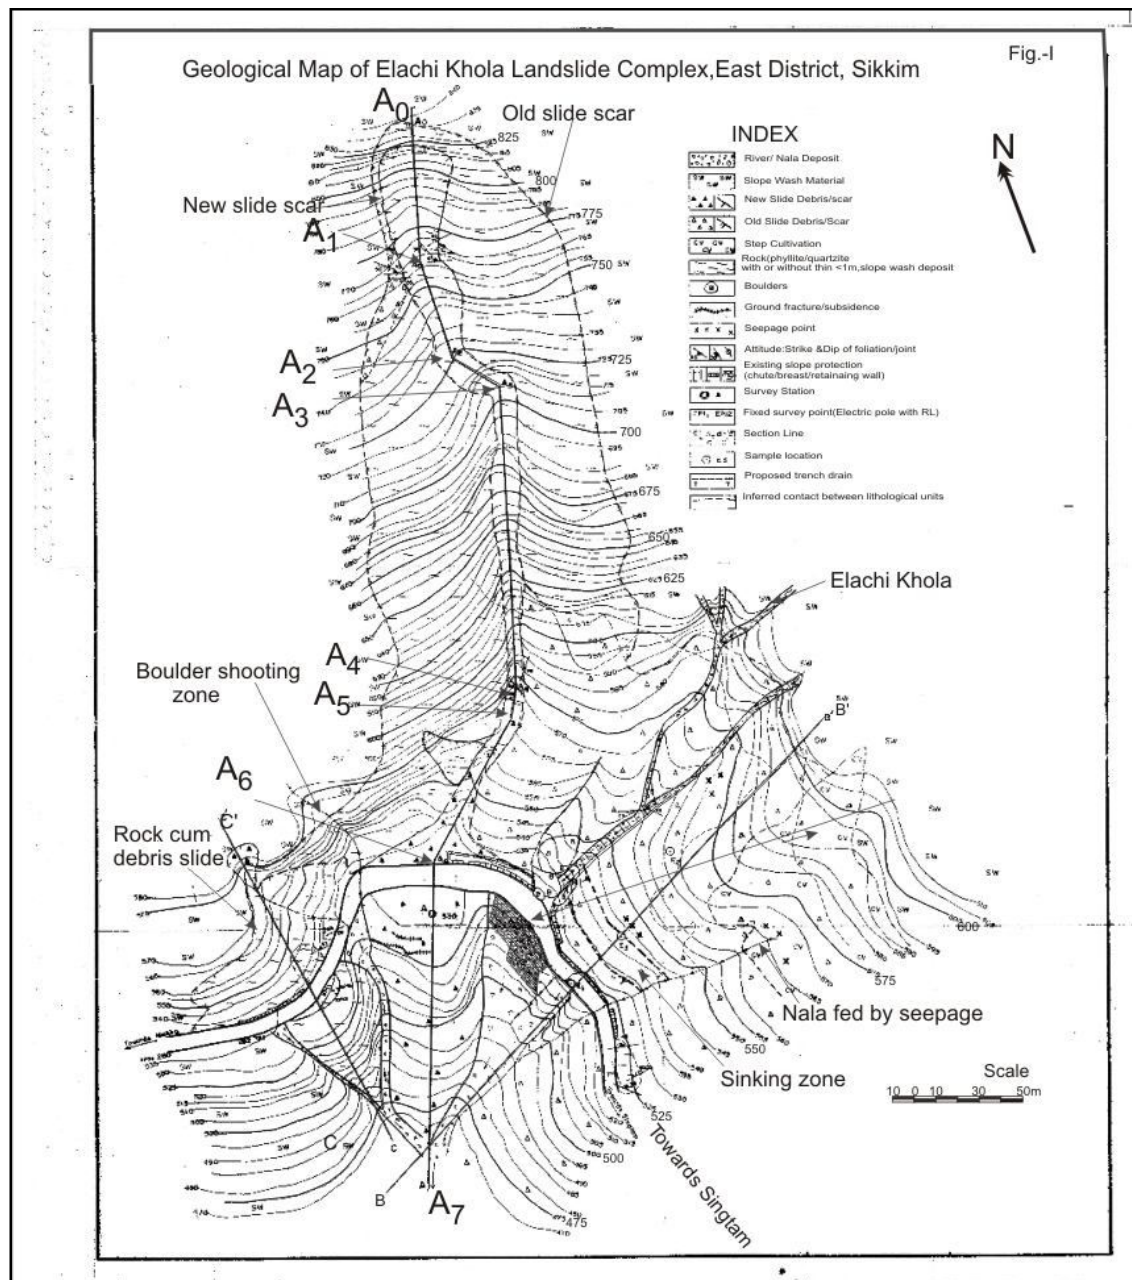
Figure 1 Geological Map of Elachi Khola Landslide Complex, East District, Sikkim

The main rock slide is located at the central portion of the area (figures 1 & 2). The rock slide initiated in 1984 and its activity continued since then (picture 1). The slide probably activated in an old slide scar. Tall vertical trees are found to occur beyond the rim of the old slide scar. The area between old and new scars is covered with grass and shrubs as big trees are not supported in rocky slope due to removal of soil cover during old slide event. The upper limit of old slide scar reached upto EL 840m i.e. about 310m above the road bench. The crown of new slide reaches upto EL 825m i.e. 295m above the road bench. The surface of the old as well as new slide scar is entirely rocky consisting of phyllites, quartzites and quartz-sericite schist.

The sinking zone is located east of the rock slide zone, i.e., towards Singtam side (figures 1 & 4 and picture 2). Elachi Khola flows along the northern boundary of the sinking zone. A perennial nala fed by ground seepage marks the southern boundary of this zone. Further south, rock is exposed at the edge of the road bench. Gradual sinking/subsidence and creep movement of the ground including the road bench is a common phenomenon at this site especially during rainy season and has left the imprints of successive damages on the retaining structures both above and below the road bench.

It is located to the west of the boulder shooting nala and affected about 35 m road length. The slide has initiated from the uphill slope cut face of the road bench. The height of the slide scar varies from 30-60m from the road bench, i.e., EL 560-590m (figures 1 & 3 and picture 3). At this site, rock is present below a cap of 1- 2.5m thick slope wash material. The slide initiated in slope wash material due to steep slope cuts for the road bench. The rock mass has also a tendency to slide down along unfavorably oriented valley-ward dipping joints. Steep cut slope and weathering of rock coupled with percolation of rain water are the main causes of slide.

Four types of slope instabilities have been recorded. They are (a) Main rock-slide (b) Sinking zone (c) Boulder shooting zone and (d) Rock cum debris slide. The main rockslide occurs within an old slide scar. The causative factor is failure of wedges formed by intersection of different joints. The sinking/ subsidence has been recorded within old slide debris material. Removal of finer particles is the main causative factor for the subsidence interpreted from surface geology supported by laboratory tests. The boulder-shooting zone is restricted to a steep gradient perennial nala along which small boulders come down during high discharge in the monsoon. The rock cum debris slide has resulted due to sliding of slope wash material and wedge failure of rock from the steep cut slope of the road bench.

Shotcrete, rock bolting, draining of subsurface water through perforated pipes, contour and chute drains have been suggested to contain the rock slide. A series of trench drains filled up with filter material for preventing removal of finer particles, beside benches, breast and retaining walls in form of gabions are required as protective measures to stabilize the sinking/subsidence. In regard of boulder shooting zone a boulder catcher is suggested. Benches, retaining walls, stitching of unfavorable wedges through rock bolts have been suggested for rock cum debris slide,
