PECULIARITIES AND GEOTECHNICAL EVALUATION OF SPILLWAY STRUCTURES IN TEHRI DAM PROJECT

S.K. Ghildyal*, Bhupendra Singh*, P.K. Gajbhiye* & D.P. Dangwal*

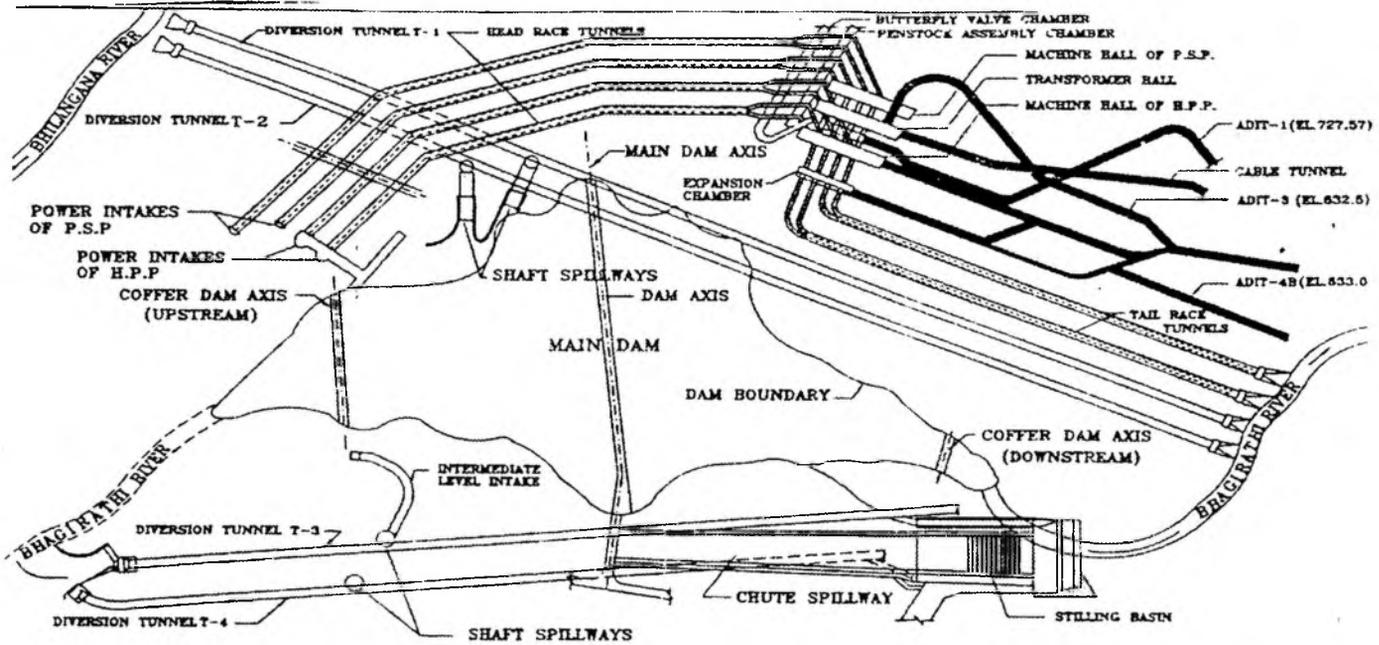
Fig : 1 Layout of Tehri Dam Project Showing location of six spillways

attributes. Tehri dam spillways have been designed to cater for a probable maximum flood (PMF) of 15,540 cumecs corresponding to a flood frequency of 1 in 10,000 years considering the hydrometeorological condition in its reservoir catchment of 7511 km². For passing the estimated routed flood of 13,200 cumecs following spillway arrangements have been finalised after taking into consideration the various geotechnical aspects and detailed model studies carried out by Hydroproject Institute, Moscow and UPID (IRS) (Fig -1).
